DESCRIPTION

Aperia has replaced the current stainless steel tamper-resistant bolts with new grade 8 steel bolts (see Figure 1 and Table 1).

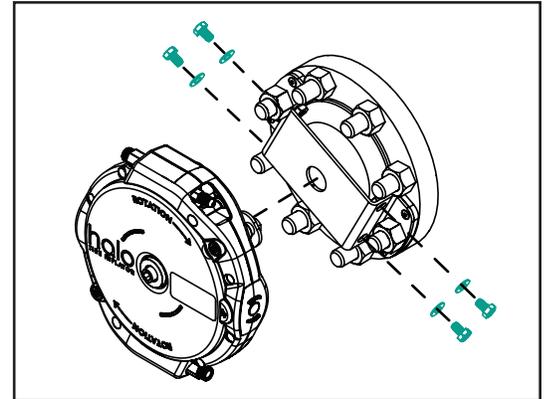
This is a running change, intended to prevent stripping at the Torx interface and improve fastener reliability.

Figure 1. Updated bolts in teal

The stainless steel bolts can be distinguished from the grade 8 bolts by looking at the surface finish and/or the presence of a nylon thread-locking patch. The stainless steel screws will have a more polished, shiny finish; while the grade 8 bolts will have a matte gray finish and a nylon thread-locking patch on the threads.

- Replace stainless steel bolts with the updated grade 8 bolts at the next preventative maintenance.
- Take care when loosening and tightening bolts to avoid stripping Torx interface.
- Tighten grade 8 bolts to 20 +/- 2 ft-lb and check for proper torque at each subsequent preventative maintenance.
