DESCRIPTION

Aperia is clarifying the torque recommendation for the trailer bracket mounting screws (Fig. 1) to ensure that the hub cap manufacturer specification is 16 ft-lb or above. The screw torque should be inspected at each PM to ensure the Halo system and hub cap remain securely attached to the vehicle.

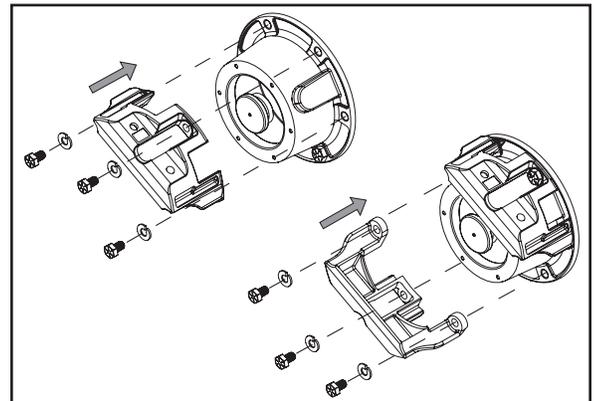
Figure 1. Trailer bracket mounting screws

The trailer mounting brackets have been engineered to exceed the Halo's advertised lifetime. Ensuring proper torque and regularly inspecting to maintain proper torque will ensure continued safe operation. Since the Halo is typically removed to check hub lubricant levels at each PM, Aperia recommends synchronizing the torque inspection with the PM.

Confirm your hub cap manufacturer's screw torque specification is at or above **16 ft-lb**.

DO NOT install the Halo on a hub cap with a torque rating below 16 ft-lb. Replace the hub cap with a different hub cap if necessary.

Make sure that longer Aperia-issued screws and washers are used to install brackets. To obtain replacements contact customer service.

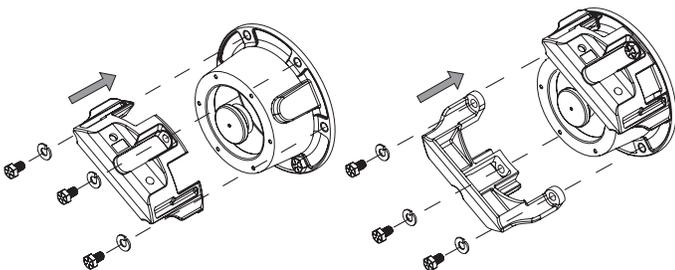
3. Re-tighten screws at each preventative maintenance.

▲ WARNING: Failing to use the longer Aperia issued screws may lead to the Halo detaching from the vehicle during driving. Ensure that at least six threads engage with the hub when installed.

Under or over-tightening the screws that secure the mounting bracket to the hub cap may result in the Halo detaching from the vehicle and a rapid loss of tire pressure.

Torque: 16 ft-lb (22 N m)

Screws may turn slightly when re-tightening.
